CHRISTOPHER F. AMER

The Malcolm Boat: A Preliminary Report

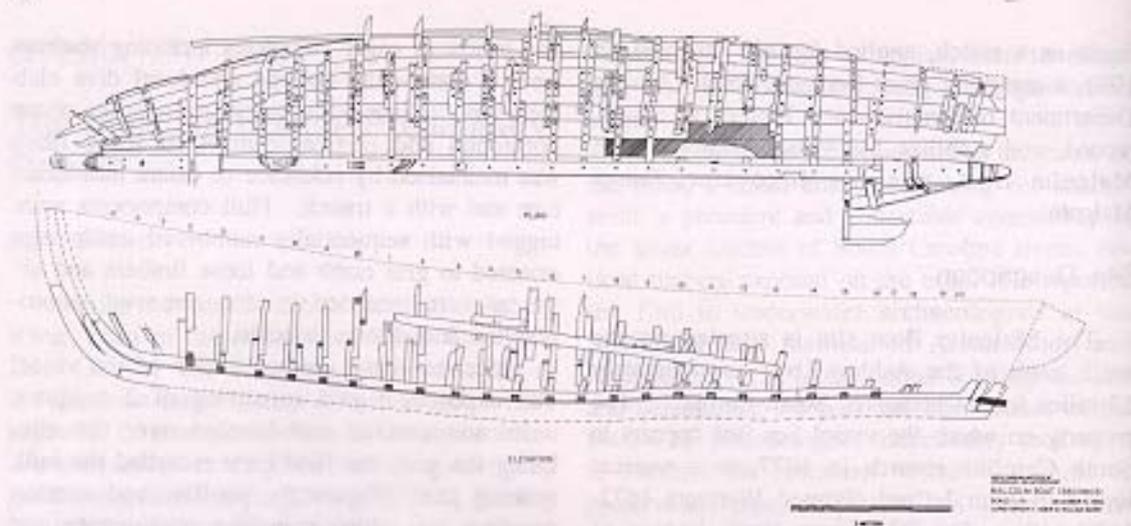
FIGURE 2. Plan view of hull remains excavated in the 1991 field season (Drawing by Christopher Amer and William Barr, SCIAA).

Once the entire starboard side of the vessel was exposed, a grid consisting of 2-m-square units was erected and leveled over the site. Using the grid, the field crew recorded the hull, making plan (Figure 2), profile, and section drawings and taking numerous photographs and photo montages, using a photo tower, to aid in the reconstruction of the vessel.

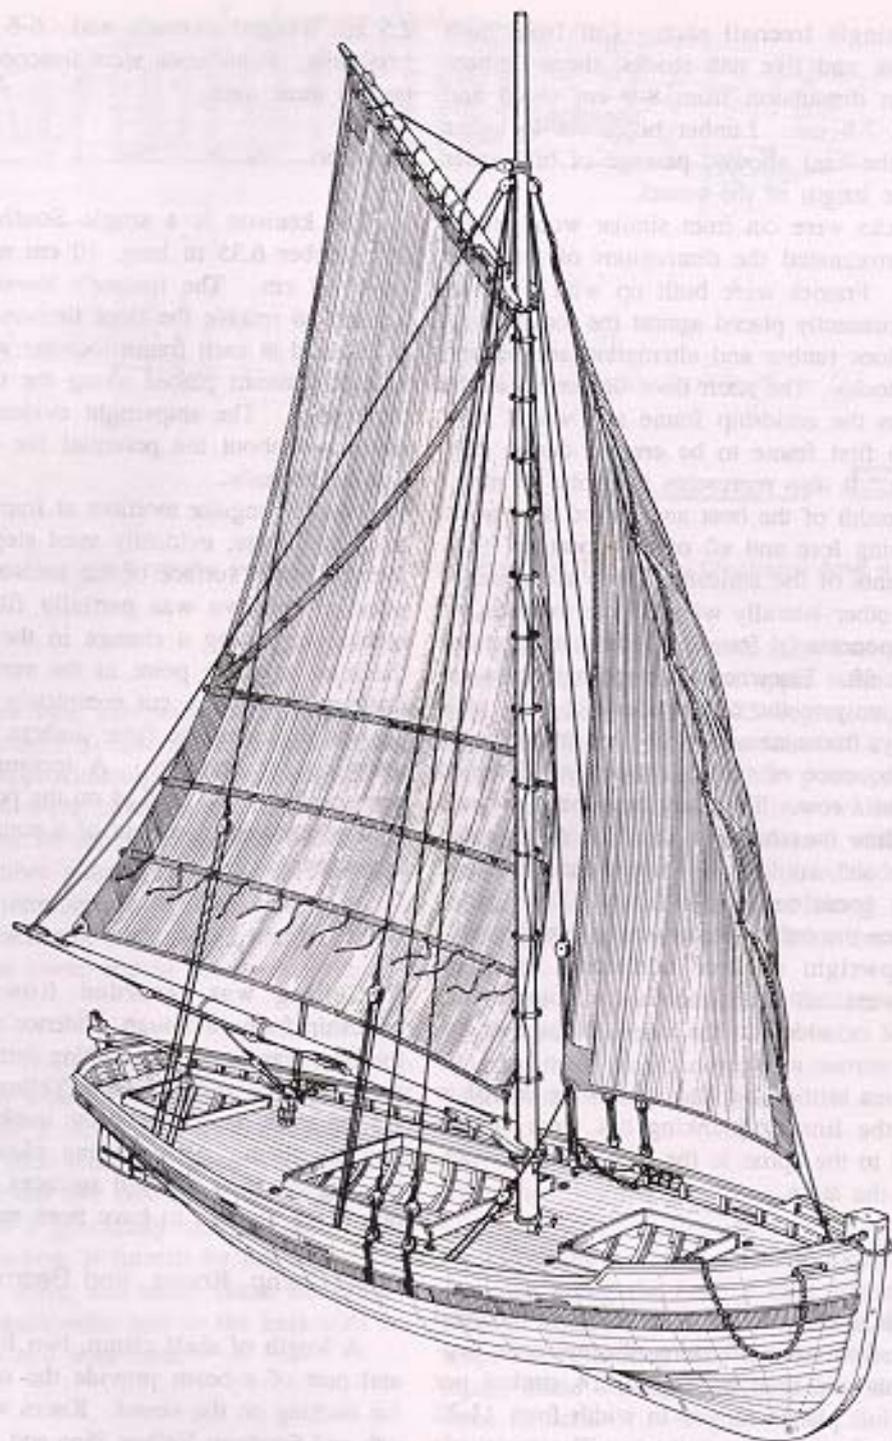
FIGURE 3. Preliminary reconstruction of the Malcolm Boat. Drawing by William Judd.

Analysis of the remains reveals a round hulled, keeled vessel with a transom stern (Figure 3). The reconstructed hull is 12 m long has a beam of approximately 4 m and an estimated depth of hold of 1.7 m. A displacement of approximately 23 tons is suggested. The vessel had a fairly sharp entry below the waterline. She had a full bodied midsection that carried aft to the transom. The construction features observed on the hull, numerous made frames along the cargo area of the hull and flexible end timbers, additional futtocks installed and a keelson notched over and fastened to each frame, suggest a boat designed with the ability to carry heavy loads. Yet the hull would have had a graceful shape and was no doubt pleasing to the eye.
